**SAFETY
RECALL****SR13-31**

| DATE : AUGUST 2013 | SECTION : 12-BRAKE |
| SUBJECT : MGM Type 24 J-series piston parking brake chamber | |

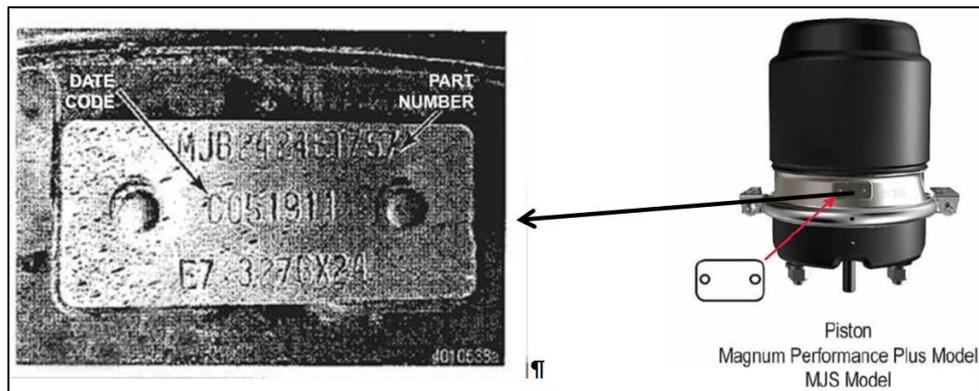
1. This recall involves inspection of the brake chambers for the suspect date code and replacement if found.
2. Check the date code on the brake chamber identification tag. If the date code has a prefix of "C" AND falls on or between November 23, 2010 and March 31, 2012 AND has one of the part numbers listed, the brake chamber must be replaced.
3. The ID tag on the chamber includes the chambers part number and manufacturing date. The date code is in the format of a letter code (signifying build location), followed by build date in a double digit format Month/Day/Year format.

Recalled Part numbers :

4. If date code is between C112310 (November 23, 2010) and C033112 (March 31, 2012) inclusively, part must be replaced.
5. Inventory parts must be inspected as well as parts installed on vehicles. All parts must be located and replaced.
6. Only parts found with a part number listed on this document AND the suspect date code range of C112310-C033112 require replacement.
