2. PROPELLER SHAFT

2.1 DESCRIPTION

3. PROPELLER SHAFT MAINTENANCE DIRECTIVE

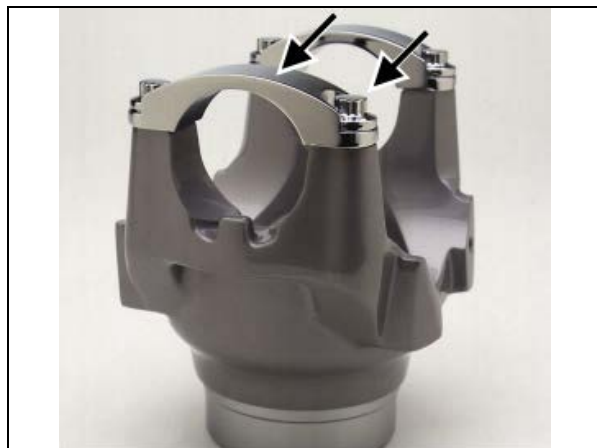
FIGURE 2: COLD FORMED BEARING RETAINER AND BOLTS AS USED ON PREVOST VEHICLES

DO NOT reuse **cold formed bearing retainers** and **bolts**. Reuse of bearing retainer and bolts can cause driveline failure, which can result in separation of the driveline from the vehicle.

- **All universal joints securing hardware (bearing retainers and bearing retainers bolts, spring tabs and bolts) must be removed and replaced** using new OEM specified replacement parts (FIGURE 1 & Figure 2).

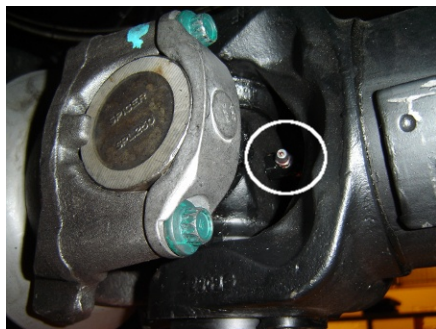
1. Use recommended lubricant to purge **all** four seals of each universal joint. This flushes abrasive contaminants from each bearing assembly and assures proper filling of **all** four bearings.

FIGURE 5: BEARING LUBRICATION ZIRK

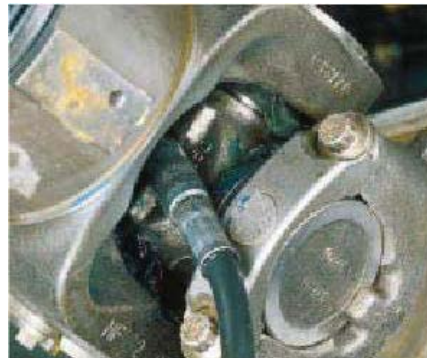
2. Make sure fresh grease is evident at all u-joint bearing seals.

FIGURE 6: BEARING LUBRICATION

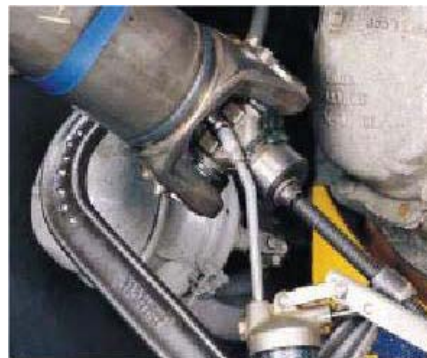
3. If any of the seals fail to purge, try to move the propeller shaft from side-to-side while applying grease gun pressure.
 - a) If all four bearing positions still do not purge, releasing seal tension may be necessary.
 - b) Remove the bearing retainer bolts and bearing retainers and discard. Do NOT reuse.
 - c) Once the bearing cups are free, allow the propeller shaft to rest on the support strap.
 - d) Apply a c-clamp around the inboard bearings.

FIGURE 7: C-CLAMP

- e) Apply grease gun pressure. Completely purge both bearings.
- f) If bearings still do not purge, complete the removal of the u-joint and inspect for blockage.
- g) If the u-joint still do not purge at all four positions after following the steps in this procedure, replace the u-joint.

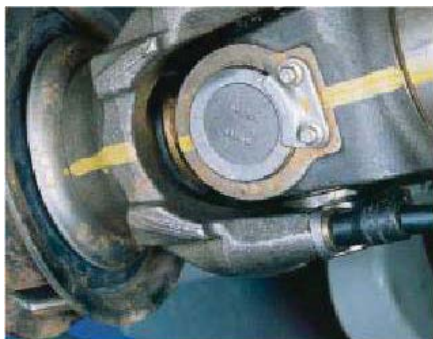
- Mark all mating propeller shaft components with a paint marker to assure proper phasing during reassembly.
- Reassembly of a propeller shaft that is out of phase can cause vibration and failure to propeller shaft components.

FIGURE 9: PHASING MARKS

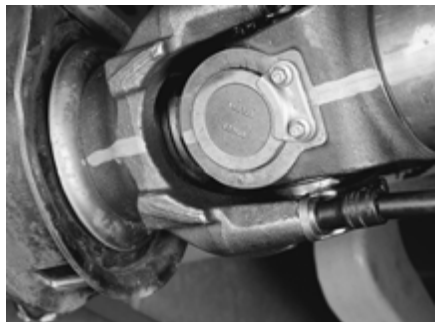
1. Mark propeller shaft (phasing marks). It is imperative to mark all the mating components of a propeller shaft, as illustrated below. Mark the propeller shaft with a marking stick, paint marker or other legible marking device. In addition, be sure to mark all bearing positions, spline positions and shaft locations. This assures proper reassembly of the propeller shaft into the vehicle, in its original position.

FIGURE 10: PHASING MARKS

FIGURE 11: PHASING MARKS

FIGURE 12: PHASING MARKS

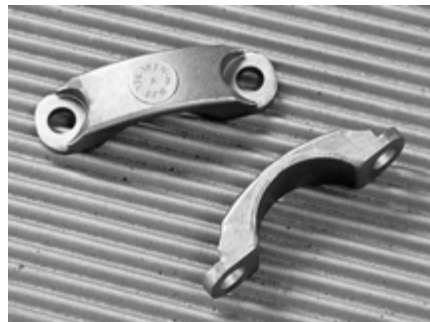
2. Be sure to ALWAYS use support straps to prevent the propeller shaft from falling out of the vehicle.
3. Remove the bearing retainers and bolts at rear end. Discard bolts, and bearing retainers.

FIGURE 14: COLD FORMED BEARING RETAINERS

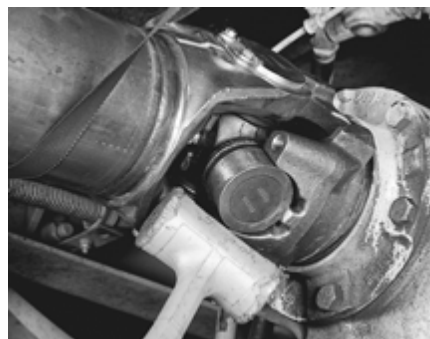
4. It may be necessary to unseat bearing cup assemblies by tapping on yoke or bearing cup with a soft-faced hammer. Once the bearing cup assemblies are free, collapse the propeller shaft until both bearing assemblies clear the open end yoke cross holes. Allow the propeller shaft to rest on support strap.

FIGURE 15: UNSEATING BEARING CUP ASSEMBLIES

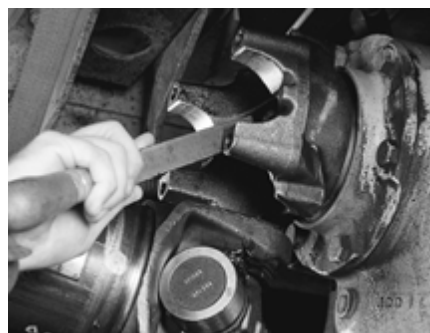
5. Remove bearing retainers and bolts at the front end.
6. Inspect all end yoke cross hole surfaces and bolt hole threads for damage. If the bolt hole threads are damaged, the yoke must be replaced.
7. Inspect for raised metal or fretting on open yoke cross holes can be removed with a fine-toothed file and/or emery cloth.

FIGURE 16: RAISED METAL OR FRETTING ON OPEN YOKE CROSS HOLES

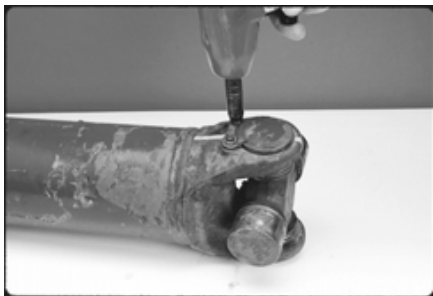
1. **For Quick Disconnect Style:** Remove spring tab bolts and discard, and remove outboard bearing cap assemblies.

FIGURE 17: SPRING TAB BOLTS REMOVAL

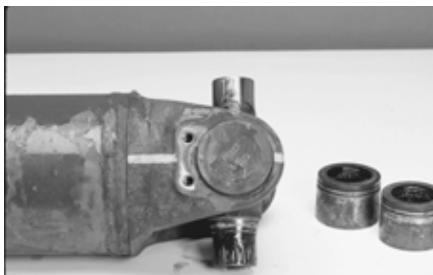
2. Make sure universal joints cross assembly is not tilted in the yoke. Place bearing cup spacer onto the base of the arbor press and under the yoke. If the arbor is larger than the bearing cup diameter, a smaller diameter push rod will be needed to avoid damaging the yoke or bearing.

FIGURE 18: CORRECT POSITIONING

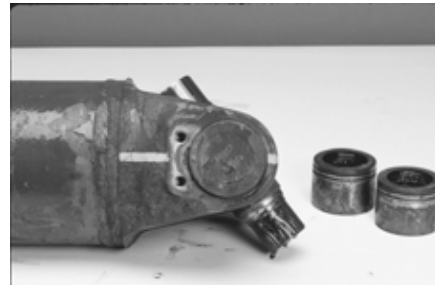
FIGURE 19: INCORRECT POSITIONING

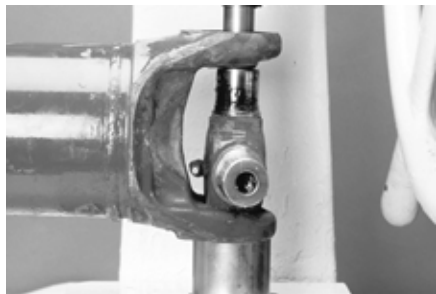
FIGURE 21

4. The bearing cup is not designed to drop out of the yoke. Move the partially pressed-out bearing cup from side to side, to "walk" the bearing cup out of the yoke ear. Remove the bearing cup from the trunnion.
5. Place the yoke in the press, with the remaining bearing cup face down. Using a push rod, press on the end of the journal cross trunnion. Continue to press down on the journal cross trunnion until the shoulder of the journal cross makes contact with the inside of the yoke ear.

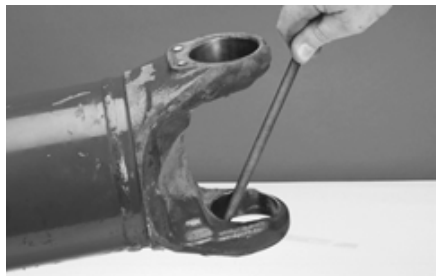
1. Inspect the tube yoke and flange yoke (if applicable) cross hole surfaces for damage or raised metal. Raised metal or fretting can be removed from yoke cross holes with a fine-toothed file and/or emery cloth.

FIGURE 22: RAISED METAL OR FRETTING CAN BE REMOVED FROM YOKE CROSS HOLES WITH A FINE-TOOTHED FILE

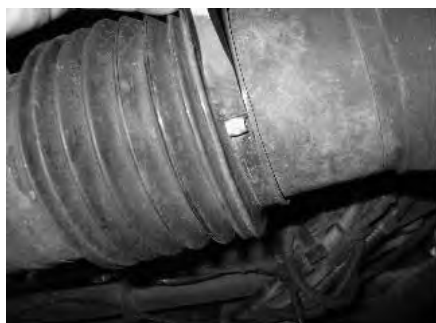
1. It is imperative to mark all mating components of the propeller shaft. Mark the propeller shaft with a marking stick, paint marker or other legible marking device.
2. Remove and discard both boot clamps. Clamps may be separated using a chisel to disengage locking hooks. DO NOT reuse clamps.

FIGURE 23: BOOT CLAMP

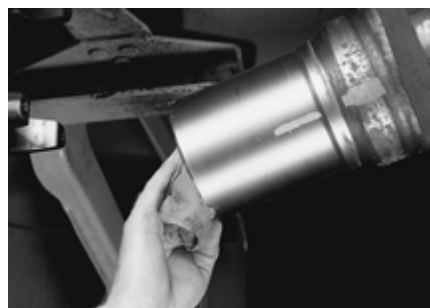
1. Clean ALL grease from yoke shaft and spline sleeve. Make sure grease-cutting solvent does not intrude into the tube through the vent hole in the spline sleeve plug. Be sure the phasing marks made during disassembly are not removed.

FIGURE 24: CLEAN GREASE FROM SPLINE SLEEVE

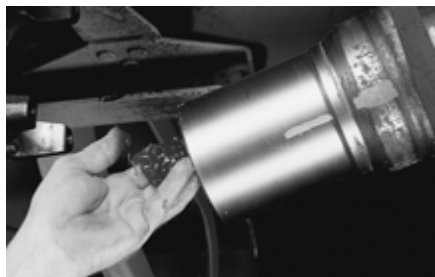
- After all traces of grease and cutting solvent have been removed from the yoke shaft and spline sleeve, apply half of the grease provided to the yoke shaft splines and the other half to the spline sleeve, cover the entire splined surface.

FIGURE 25: APPLY GREASE

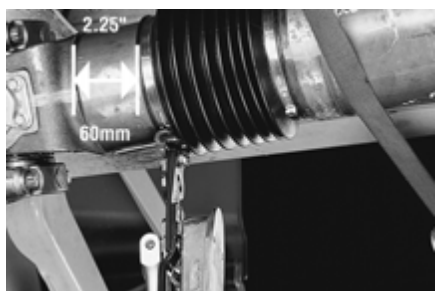
- Measure and place a mark 2.25 inches (55-60mm) from yoke shaft shoulder with a marking stick, paint marker or other legible marking device.

FIGURE 26: POSITION THE END OF THE BOOT AT THE 2.25 INCHES (55-60MM) MARK MADE ON THE YOKE SHAFT SHOULDER

- Position a clamp on each end of the new boot. Slide the boot onto the grease-free yoke shaft shoulder.
- Collapse the boot and insert the yoke shaft into the splined sleeve, making sure phasing marks are in line. Position the end of the boot at the 2.25 inches (55-60mm) mark made on the yoke shaft shoulder and tighten boot clamps to the specified torque. Yoke shaft shoulder must be clean, dry and grease free.

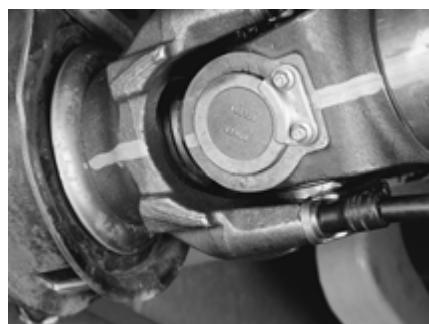
- Before installing the propeller shaft, inspect the yoke surface for burrs and damage. Mating surfaces should be clear of rust, contamination and grease.
- With safety straps in place, align the phasing marks between the yoke and propeller shaft.

FIGURE 27: ALIGN THE PHASING MARKS BETWEEN THE YOKE AND PROPELLER SHAFT

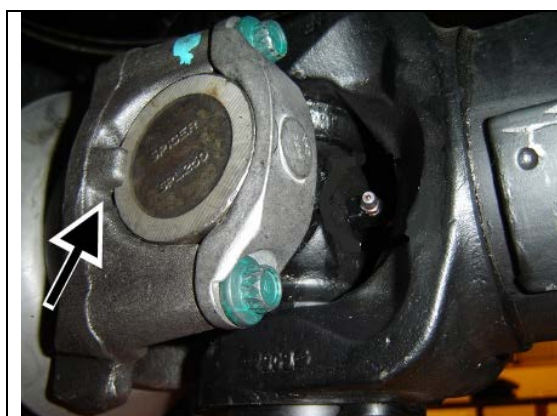
- Align the bearing cups with the yoke ears making sure that the cups are evenly spaced between the tabs (ears) of the yoke. A soft faced hammer can be used to fully seat the bearing cups into the yoke.

FIGURE 28: YOKE TAB (EAR)

Note: Bearing cups must be fully seated between the yoke tabs (ears). Failure to seat the cups properly will result in a premature failure.

- The universal joint caps must be seated properly between the yoke tabs (ears) (FIGURE 28).
- All universal joint bearing retainers must have been replaced using new hardware and fasteners.
- All fasteners have been torqued properly and are torque-marked.
- Locking tabs, if used, must be bent over the bolts.
- There must be no mixing of new and old parts on a universal joint.
- The driveshaft must be phased properly.
- Driveshaft guard (hoop) must be in place.
- Driveshaft universal joints must be greased after reinstallation of driveshaft in vehicle (fresh grease showing at all u-joint end caps).

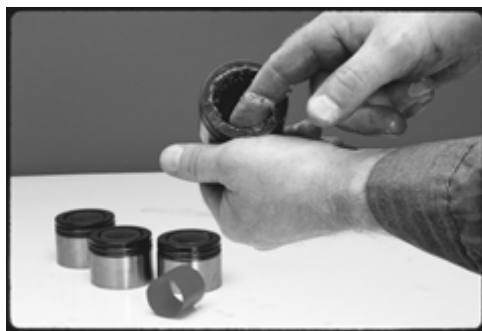
- Remove needle retaining plugs from all bearing cup assemblies. Using a high quality National Lubricating Grease Institute E. P. Grade 2 lubricating grease, wipe each bearing cup assembly with grease. Fill all cavities between the needle rollers. Also apply a liberal coating of grease on the bottom of each bearing cup assembly and on the lip of the seal.

FIGURE 29: GREASING BEARING CUP

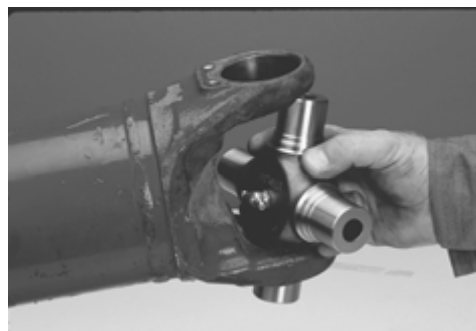
- Position the journal cross into the yoke cross holes with the grease zerk fitting inward toward tubing. The double-headed, grease zerk (nipple) fitting should be perpendicular to the yoke cross holes.

Note: Failure to properly position the universal joint will result in the inability to grease the universal joint.

FIGURE 30: POSITION THE JOURNAL CROSS INTO THE YOKE CROSS HOLES WITH THE GREASE ZERK FITTING INWARD TOWARD TUBING

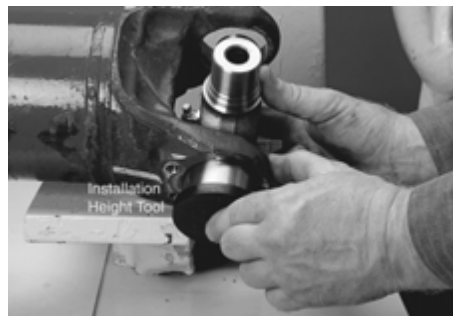
FIGURE 31

- Move one end of the journal cross to cause a trunnion to project through the cross hole beyond the outer machined face of the yoke ear. Take one bearing cup assembly and position an installation height tool on the end of the bearing cup assembly. Place the bearing cup assembly over the protruding trunnion diameter and align it to the yoke cross.

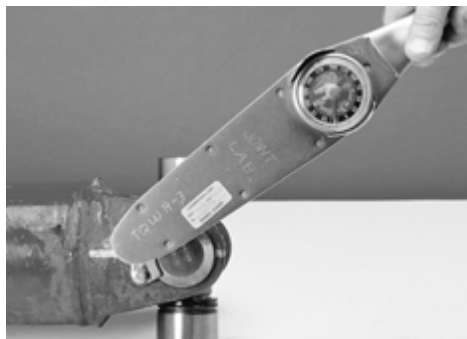
FIGURE 33

5. Flip yoke 180 degrees. Position the remaining installation height tool on the end of another bearing cup assembly. Place bearing cup assembly over trunnion diameter and align it to the yoke cross hole. Push the bearing cup assembly until both installation height tools are flush with the cross hole face.
6. Install new spring tabs and 8mm thread bolts. Make sure that no grease or foreign material is present between the contact areas of the spring tabs, bearing cups and yoke cross hole faces. Tighten bolts to the required torque.

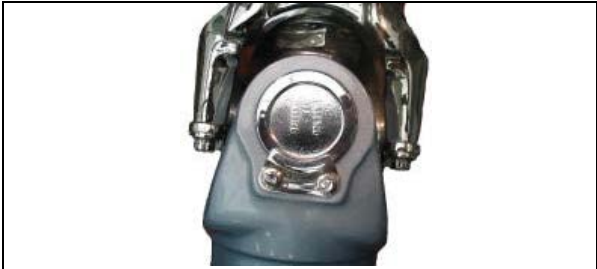
SPRING TAB BOLT TORQUE

Bolts are specially heat-treated. DO NOT substitute inferior grade bolts.

Series	Head size	Size	Bolt torque
SPL250	8mm	8mmx1.00	25-30lb-ft
	6 Points
