PREVOST

DATE: MARCH 2000	SECTION: 23 - Accessories		
EXPIRATION: MARCH 2001			
SUBJECT : WINDSHIELD WASHER RESERVOIR

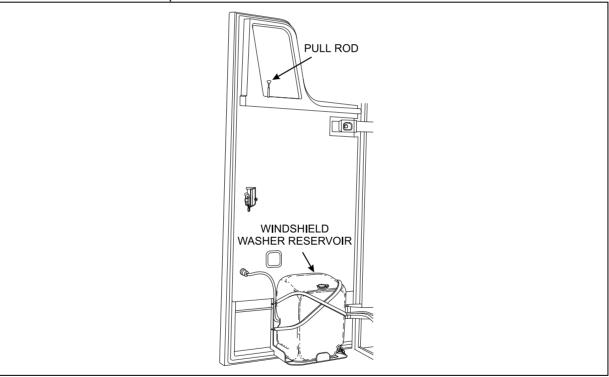
A second rubber strap must be added to hold the windshield washer reservoir firmly in place.

FIGURE 1: USE OF TWO STRAPS CROSSED OVER THE WINDSHIELD WASHER FLUID RESERVOIR

- 1. Open the front service compartment;
- 2. Install the original and the new rubber straps as shown on the figure below;
- 3. Close the front service compartment.
