WARRANTY BULLETIN

Wb00-33

SUBJECT: BRAKE PEDAL ROD LINKAGE

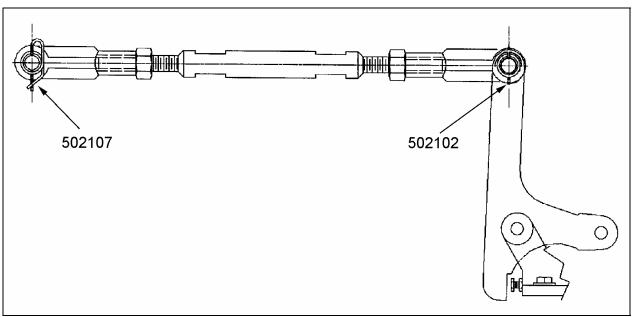
FIGURE 1: BRAKE PEDAL ROD LINKAGE

A locking pin must be installed in place of the hitch pins currently installed on the above vehicles.

- 1. Access the rod linkage through the front bumper compartment. The rod is located on the driver's side of the vehicle, close to the ceiling;
- 2. Remove the hitch pins as illustrated in figure 1 and replace with a cotter pin (#502102) on the end closest to the brake valve and a locking pin (#502107) on the other end of the rod (Refer to figure 1).
